DOCUMENTATION AND CONSERVATION OF WAZIR KHAN MOSQUE, LAHORE, PAKISTAN

Keywords: Documentation, REDM, rectified photography, damage mapping

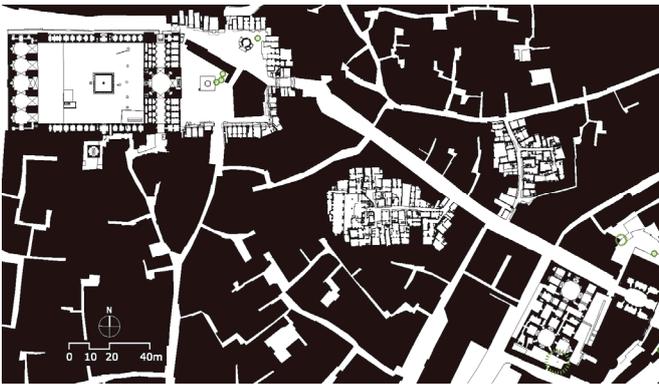
Figure 4: Plan shows the locations of major thoroughfares and monuments on the Shahi Guzargah

Located on the western side of Wazir Khan Chowk (square) about 260 meters from Delhi Gate (fig. 4), and surrounded by the thick urban fabric of the Walled City, the Wazir Khan Mosque was built by Hakim Aliuddin (sometimes also referred to as Ilmuddin) in 1634 (1054 AH). Wazir Khan Mosque complex is the centre piece of an historic urban ensemble. This ensemble including the Chowk Wazir Khan and the shops on the northern side of the mosque complex. Historically, as part of the royal thoroughfare connecting Delhi Gate and the Lahore Fort, the Wazir Khan Mosque together with its square formed a singular and very important element punctuating the urban fabric of the Walled City.

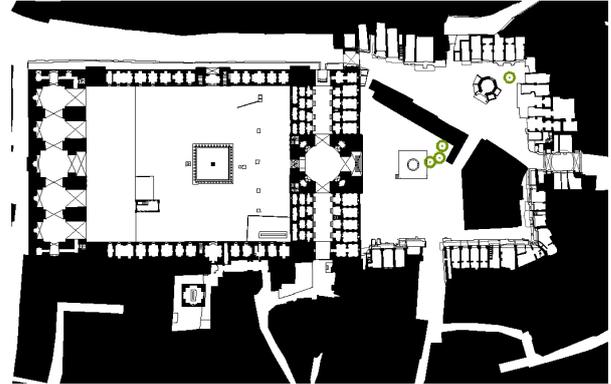
Figure 5: Plan of the entire mosque complex with Chowk

The structure of the mosque can be divided into three horizontal planes. Level 0 comprises the shops on the eastern and northern side. Level I occupy the maximum area of the mosque, comprising all the major spaces in the mosque. Level II defines the spaces which can be accessed from level I via staircases. The layout of the mosque is rectangular in plan, measuring 86.17 x 50.44 m on its extreme limits. The four imposing minars define the corners of the main courtyard. The main prayer chamber, courtyard, hujras (meditation rooms), vestibule and bazaar (fig. 5) constitute the main elements of the mosque complex.

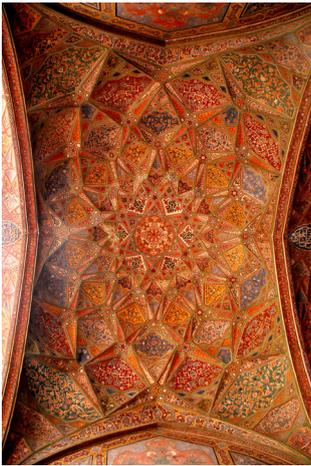
Figure 6: Detail of fresco work in one of the archways

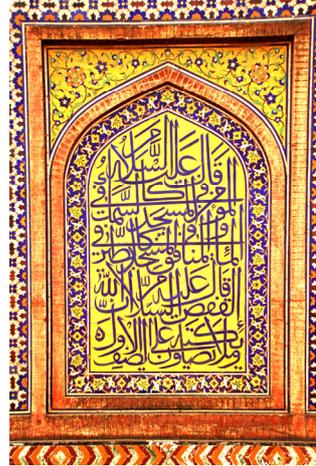
Figure 7: Rectified photograph of Arabic calligraphy

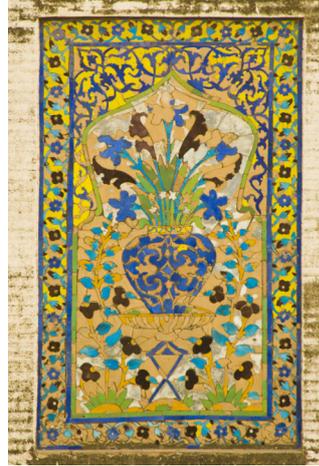
Figure 8: A rectified photograph of kashikari work with a floral pattern

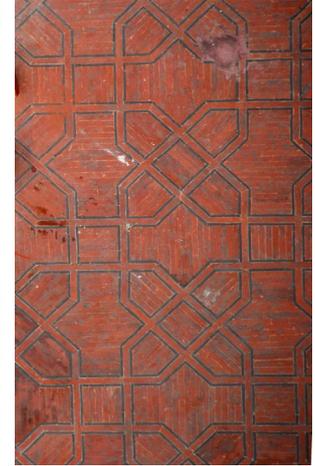
Figure 9: Brick floor pattern in the upper level of the courtyard

The intricate and delicate surface embellishments of the mosque are vulnerable to weathering, and prone to damages caused by environmental and man-made factors. All the floors in the mosque are made of brick and have a variety of geometrical patterns, particularly in the courtyard and the main prayer chamber (fig. 9). Most of the past restoration efforts were focused on the protection and conservation of these surface decorations. Almost all surface decorations, except the frescos in the main prayer chamber and entrance portal, are directly exposed to the weather conditions. The presence of hundreds of pigeons in the mosque exposes the glazed tile work to the chemical effect of bird droppings, leading to rapid deterioration of the surface of glazed tiles. This issue becomes critical when the rain water mixes with the nitrate-rich excreta and runs down on the surface decorations³.

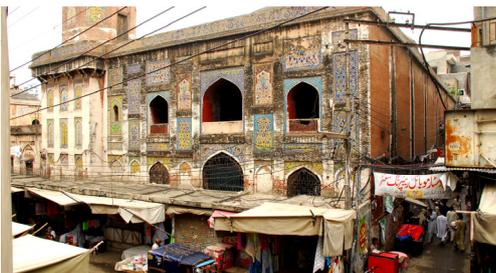
Figure 10: Northwestern corner of the mosque shows the level of commercial encroachments

Detailed inspection reveals that the structure of the mosque has been suffering from serious damage due to neglect and lack of maintenance. Most of the shops at Level 0 on the northern side are rented out for commercial activities and have been converted into stores as a result of additions built out into the street to cope with the raised street level. The structure at Level I show the majority of damage is in the form of cracks, subsidence and leaning. The cracks in the main arches of the main prayer chamber adjacent to the two minarets have a direct relationship with the leaning pattern of the minarets. Although it is not confirmed when these cracks developed, the major restoration phase in 1971-78 noticed these cracks (fig. 11). Rising damp in the walls of level 0 shops and level I hujras have damaged the surface lime plaster and in certain locations it has eroded the lime mortar constituting the masonry work.

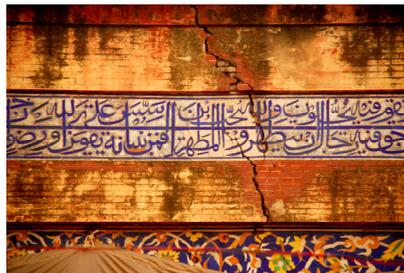
Figure 11: Major crack in the wall above the northern most archway of the prayer chamber

The cracks in the critical areas of the mosque have been identified and monitored periodically with the help of total station and Vernier digital calipers. The outward leaning of the western minar, which were recorded precisely with the help of total station, has produced some major cracks in the apex of the northern and southern arches of the main chamber. Six locations of major cracks were identified in the main prayer chamber of the mosque and each location was later equipped with a group of three stainless steel studs in a triangular formation. A detailed monitoring scheme has been set in place where the distance between each stud is recorded with the help of calipers and which can be periodically compared with recordings done at a later stage.

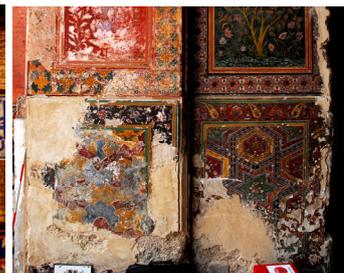
Figure 12: Rising damp in the main prayer chamber has damaged the fresco paint

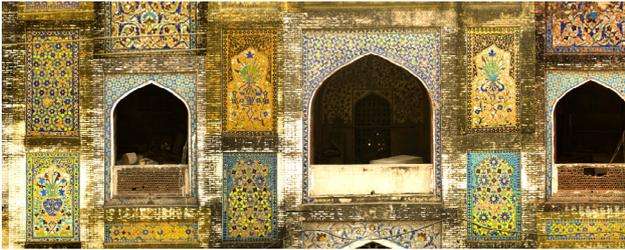
Figure 13: Deposits of soil and dust on the rendered and glazed surfaces of main prayer chamber facing north

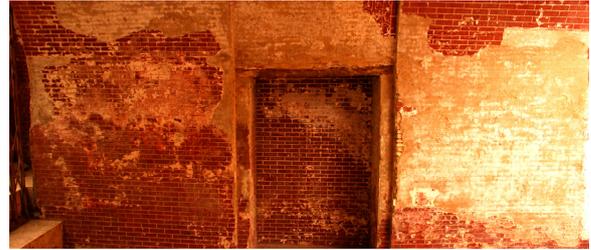
Figure 14: Efflorescence on the rendered surface (tazzakari) of the wall in the southern section of calligrapher's bazaar

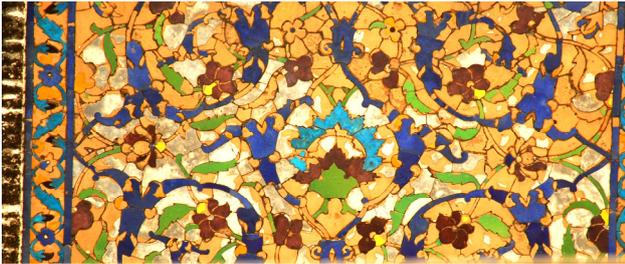
Figure 15: Exfoliation of glaze from the terracotta body of the tile is the most common damage type on the glazed tiles

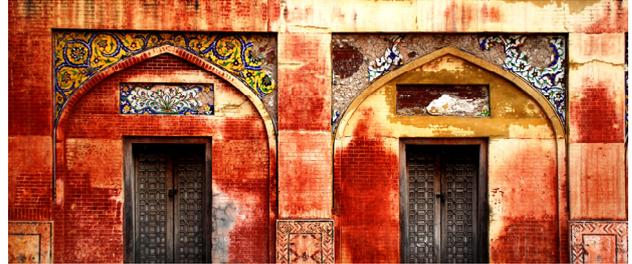
Figure 16: Fading of surface render (tazzakari) on the northern façade of hujra walls in the courtyard

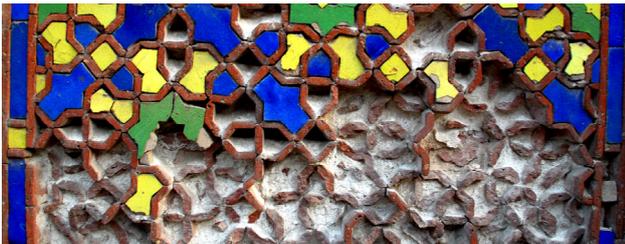
Figure 17: Loss of bond between the tile and the mortar

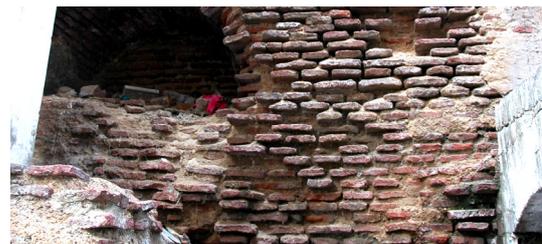
Figure 18: Sanding of mortar in brick masonry

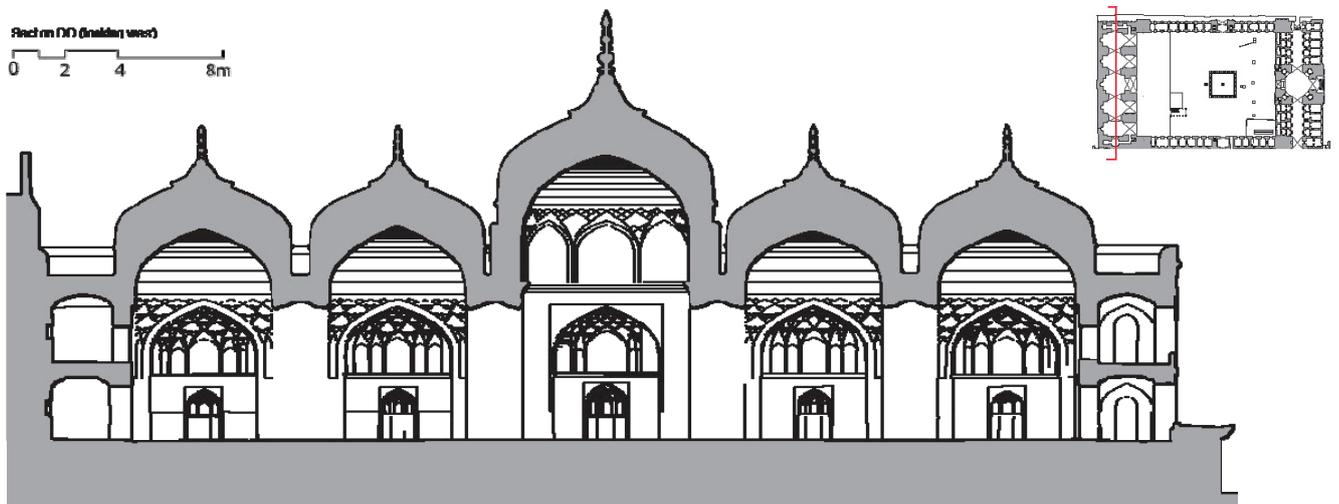
Figure 19: A sectional elevation of the main prayer chamber

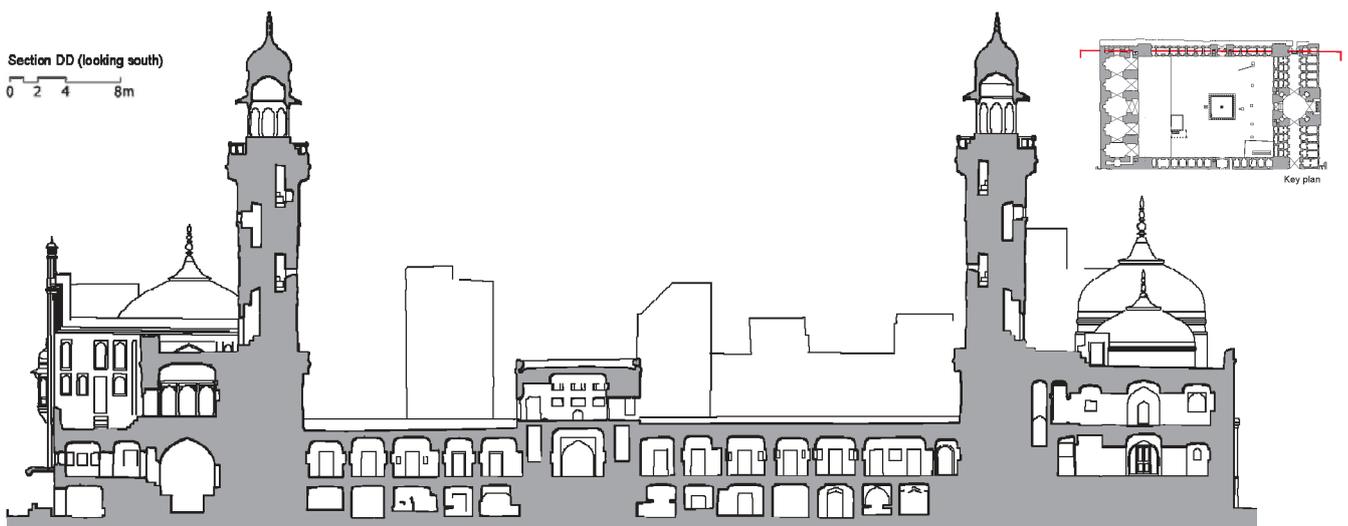
Figure 20: Longitudinal section of the mosque through the northern most section of minars, hujras, shops at level 0 and main prayer chamber

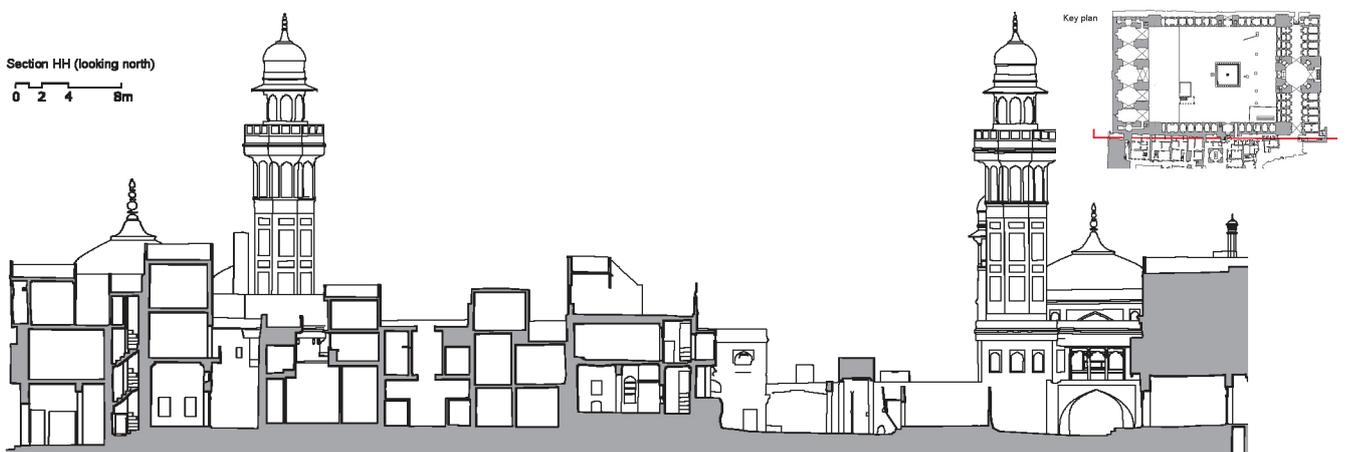
Figure 21: Longitudinal section through the neighborhood on the south side of the mosque.

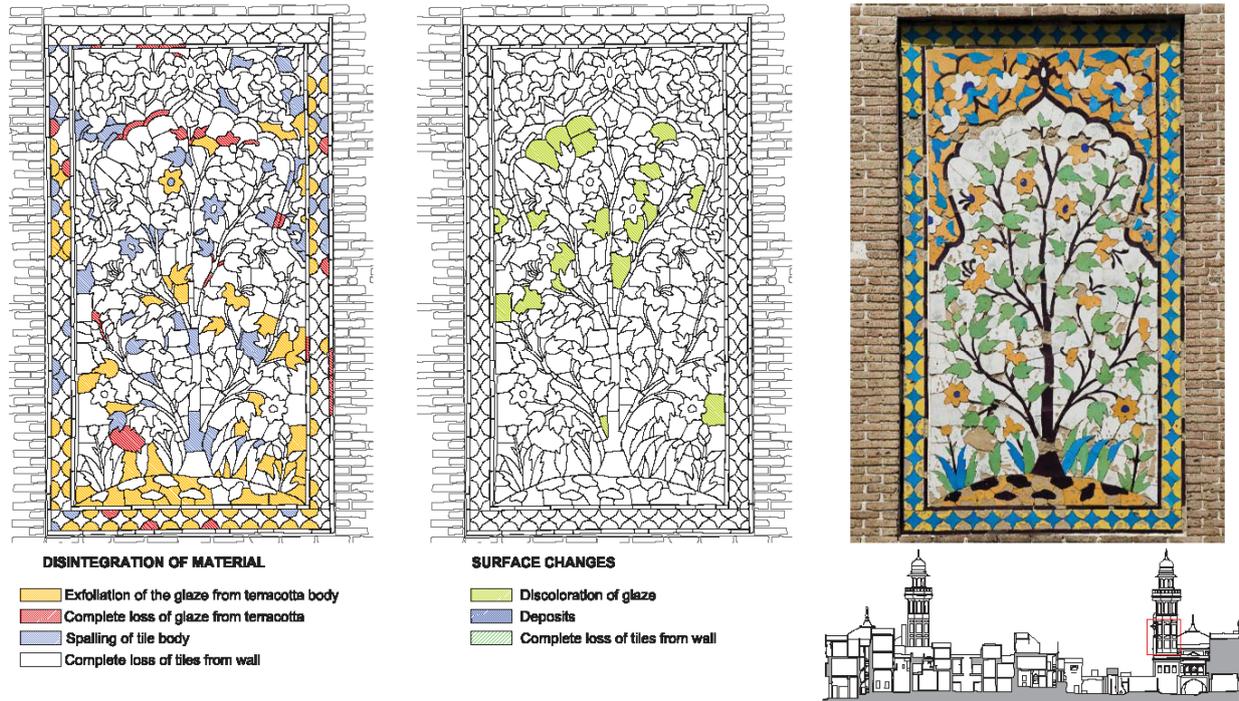
Figure 22, 23 & 24: Classification of weathering and damage forms of glazed tiles in one of the panels of south-eastern minar of the mosque. The rectified and digitized elevation of the glazed tiles panels provides accurate and precise information about the damaged areas

During the documentation REDM has been used to produce plans, sections and elevations. Additionally, it has been used to monitor the cracks in walls, settlements in the floors and the precise leaning of the four minarets. All major details of the highly decorated elevations with rare building craft techniques of the mosque have been documented with the help of photo rectification technique. Deteriorated glazed tile work (kashikari) on the facades has been documented using the photo rectification and the damages were mapped on piece to piece basis (fig. 22 & 23).

Inadequate care and maintenance threatens this world class monument in a variety of ways. A significant amount of natural and man-made damage has already occurred. It is important for the project to identify all these threats and map the weathering forms and damages to the structure both at a macro and micro scale (fig. 22-24).

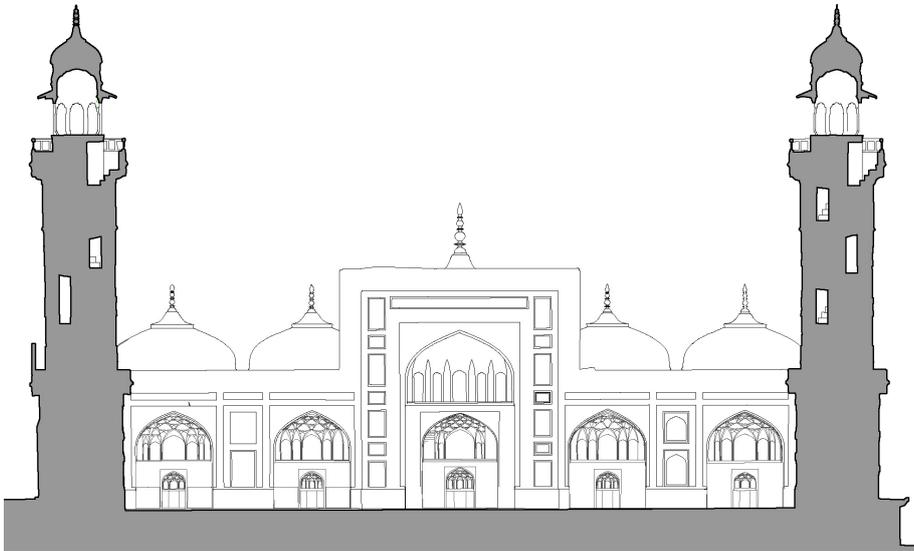
Figure 25: Drawing show the sectional elevation of the main prayer chamber through the two western minars

The REDM survey firstly provides us with an opportunity to document the tilt in the minars of the mosque. Secondly, it helps in identifying the effects and relation of tilting with major cracks in critical locations like the arches adjacent to the western minars. Thirdly, it serves as a monitoring mechanism to track the rate of structural damage such as cracks and deflections more generally. Lastly, it helps in identifying the extent and nature of the periodic settlement of the brick floor in the south-eastern corner of courtyard and its effect on the eastern minarets.

In respect of the minars, it was decided to draw four sections of each octagonal shaped minaret. In order to find the relation between subsidence and deflection in the structure, the information gathered with this survey was analyzed in reference to the results of the geo-technical investigation of the cultural fill and natural sub strata of the mosque.

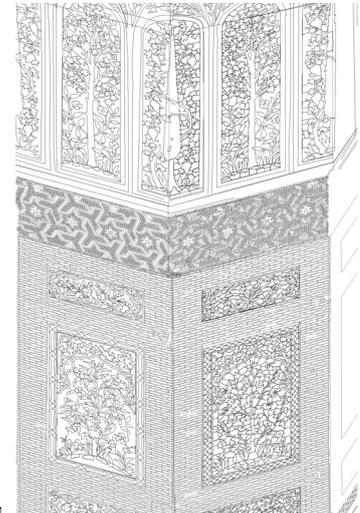
Figure 26: Drawing shows the level of detail drawn from rectified images of bricks and tiles of SE minar

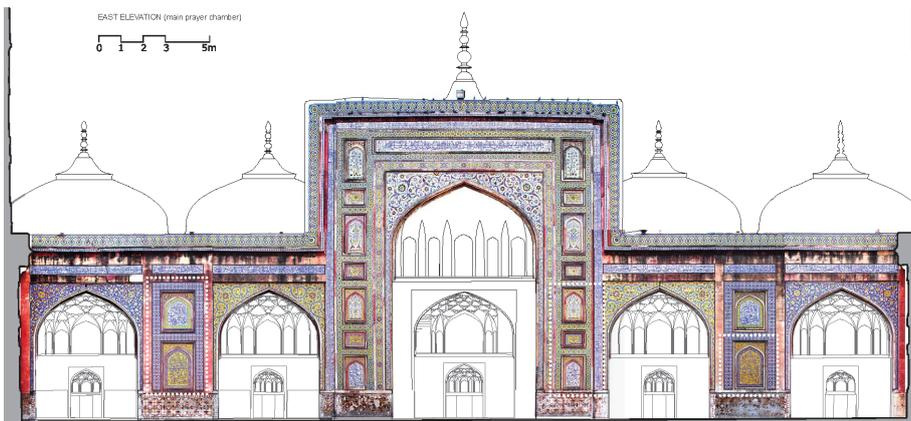
Figure 27: A photo-mosaic of the eastern elevation of the main prayer chamber. This image is produced with the help of image rectification and is plotted to scale

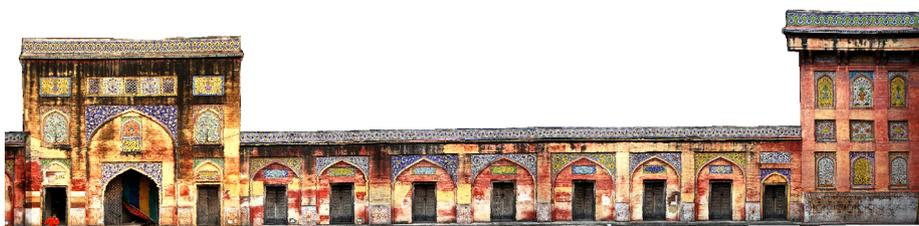
Figure 28: Section through the courtyard of the mosque shows the rectified north elevation

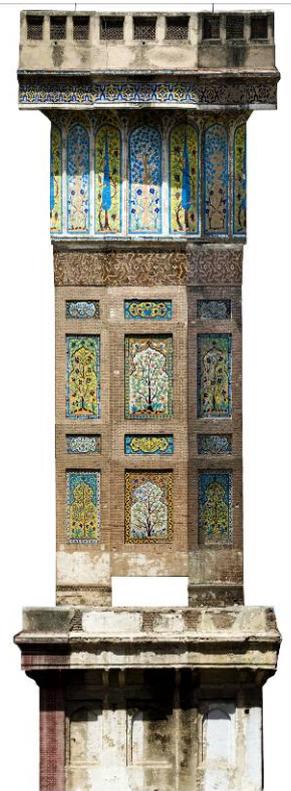
Figure 29: The southern face of the southeastern minar shows the detail of kashikari and exposed brick work
